Manhole Inspection Summary

Manhole # S21WW1002MH

Location Address: **310 SPRINGHOUSE PATH**

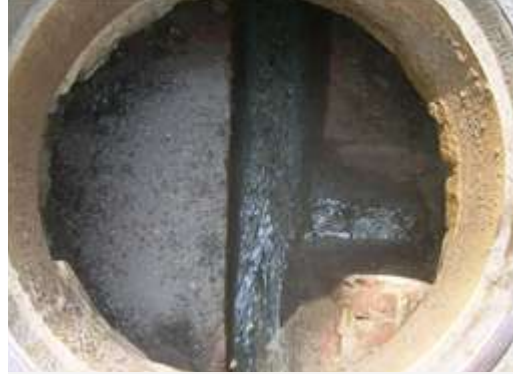
Top View

Bench debris.

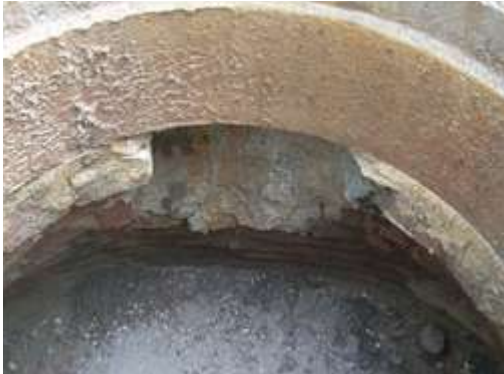
Defect

Frame leaks. Adjustment deterioration and infiltration. Corbel and Barrel infiltration - other side.

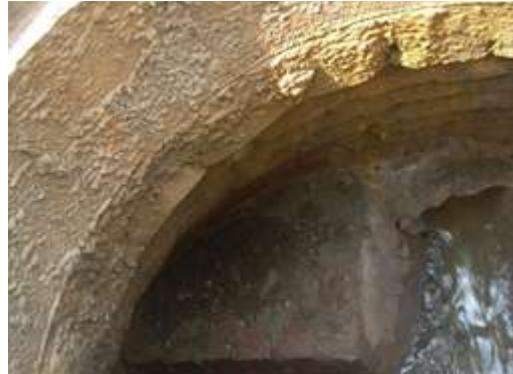
Defect

Frame leaks. Adjustment deterioration and infiltration. Corbel and Barrel infiltration.

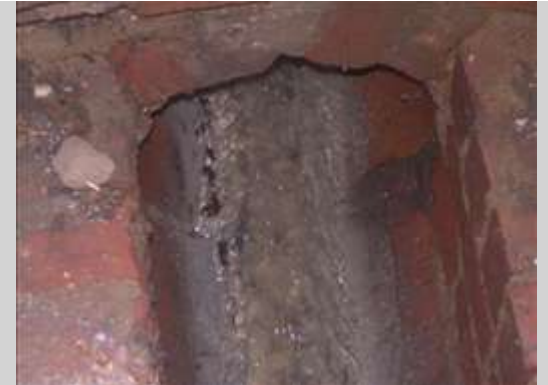
10 in. Circular Gravity Sewer Pipe Out @ 12 O'Clock

Deposits: ☐ None ☐ Mud ☐ Sludge ☐ Debris ☒ **Grease**

Silt Depth: **0** (in.) Deposits Extent: **Light**

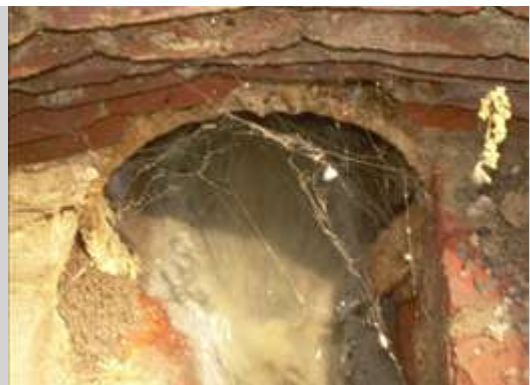
10 in. Circular Gravity Sewer

Deposits: ☐ None ☐ Mud ☐ Sludge ☐ Debris ☒ **Grease**

Deposits Extent: **Light**
